Tactical Mission REPORT

MISSION NO. 29

FLOWN 10 FEB 1945

Target: Nakajima Aircraft Factory

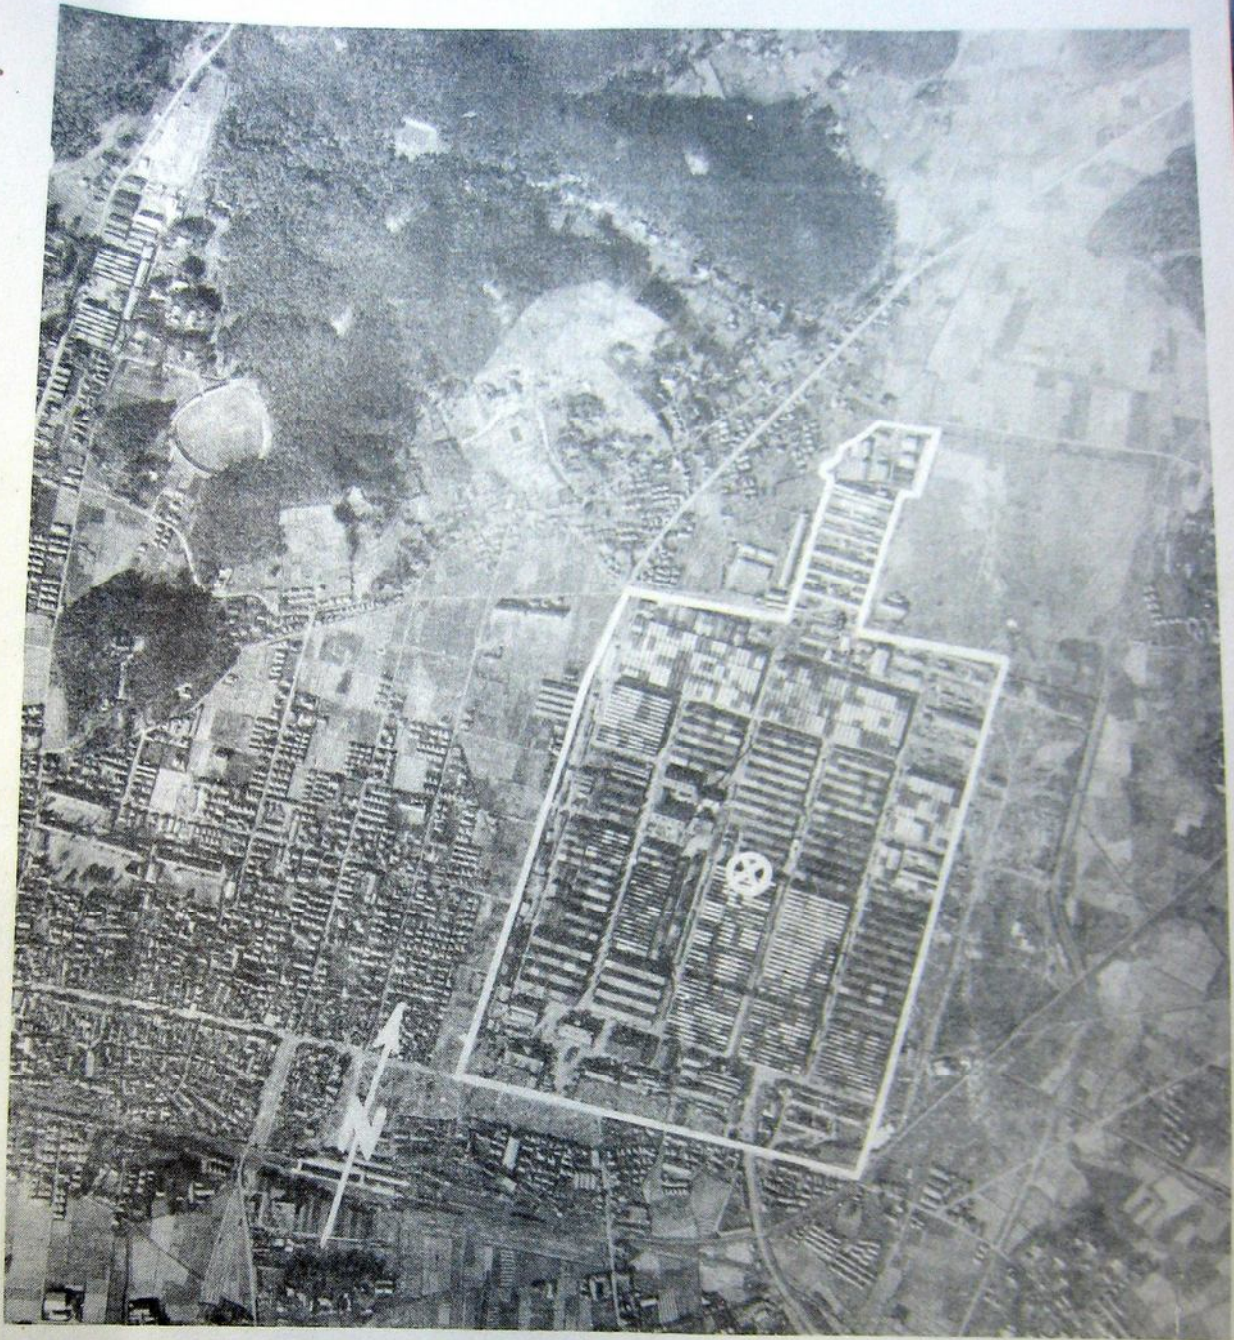
TARGET 1544
NAKAJIMA PLANT
OTA

⊗ AIMING POINT

(1) Primary Target: Nakajima Aircraft Factory at Ota:AAF Objective folder 90.13, target 1544. (Refer to XXI Bomber Command Litho-mosaic, exhibit 1, hereto.)

(2) The designated approach, axis of attack of 282 degrees, was used so that the formation would be on the axis of the widest part of the selected target area. The aiming point selected was between the ends of the westernmost parts-fabrications and sub-assembly building and the final assembly and fuse-lage-erection building. This point included the entire plant within a 1500-foot radius, which was within the circular error probable for this mission. Effective damage was insured if the bombs were dropped in the assigned aiming point area. The grid coordinates of the aiming point were 128133 on XXI Bomber Command Mosaic No. 90.13, target 1544.

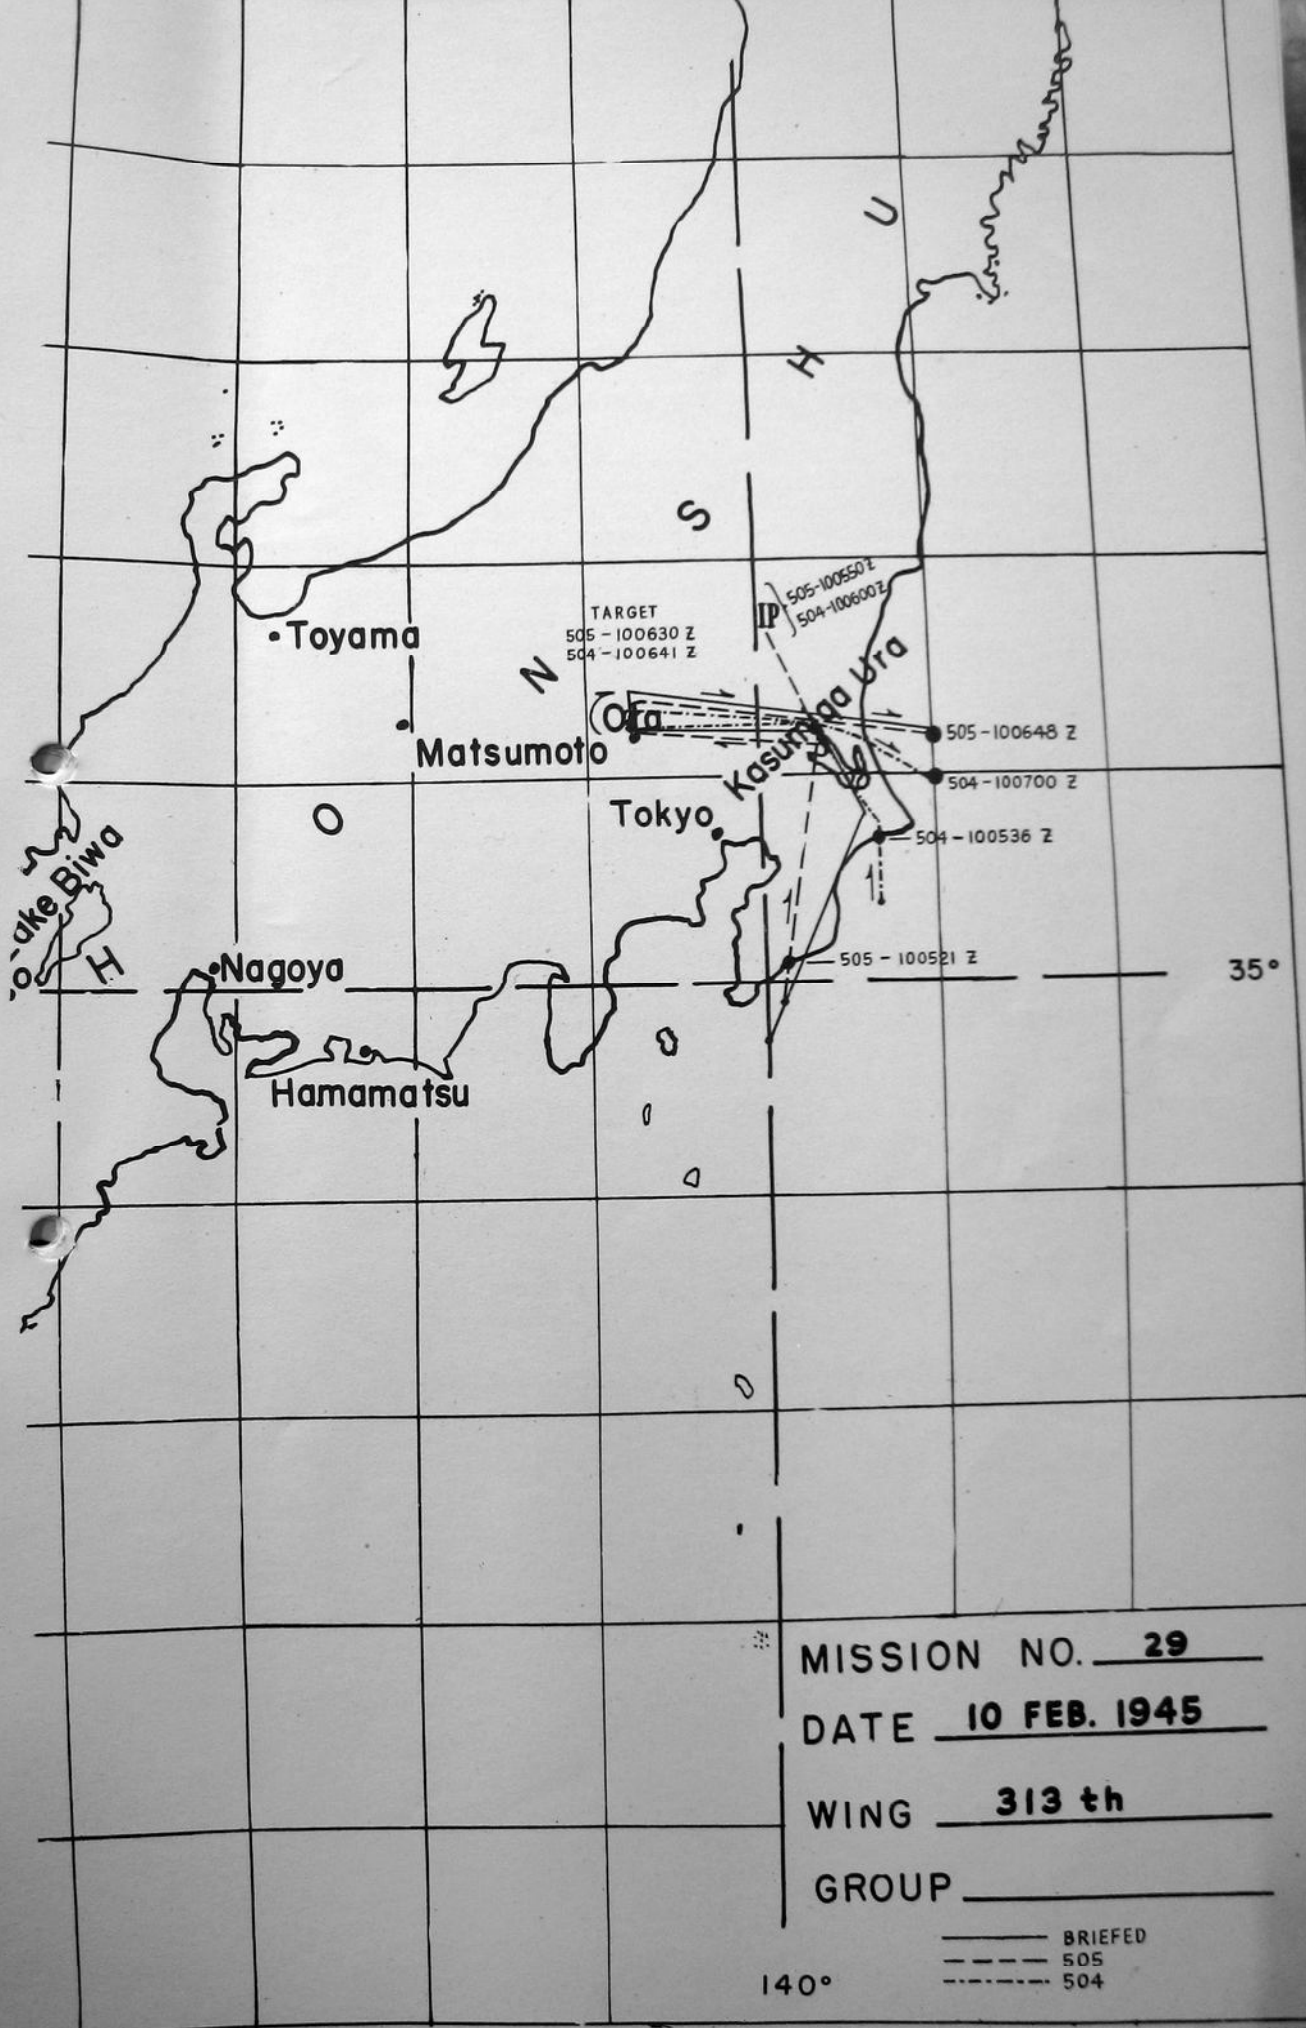
MISSION NO. 29
 DATE 10 FEB. 1945
 WING 313 th
 GROUP _____

— BRIEFED
 - - - 505
 - - - 504

505-100257 Z
 504-100242 Z

505-100201 Z
 504-100146 Z

505-092242 Z
 504-092243 Z

T.O.		LANDING	
	First	Last	First	Last
505	092126Z	092135Z	101306Z	101345Z
504	092138Z	092150Z	101315Z	101424Z

TARGET
 505 - 100630 Z
 504 - 100641 Z

IP 505-100550 Z
 504-100600 Z

———— BRIEFED
 - - - - 505
 ······ 504

4. The 313th Wing made landfall as briefed, but made too wide a turn and was blown eastward to Choshi Point. This, combined with the strong head wind, gave them a total of 45 minutes directly upwind.
